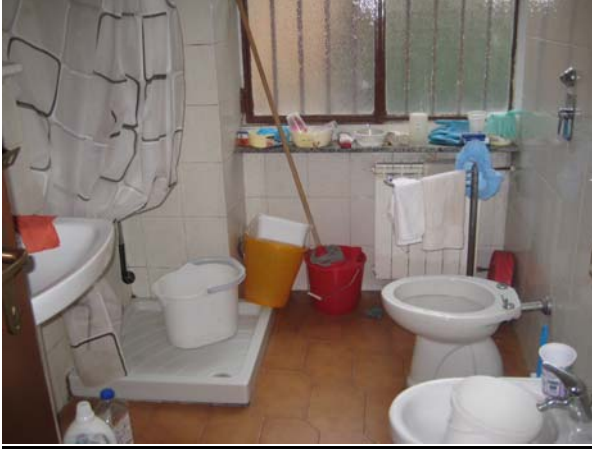
Disimpegno bagno	Particolare bagno
  A photograph showing a cluttered bathroom hallway. A metal cart is filled with blue plastic bags and other items. A white bucket and a red bucket are visible on the floor.
